STRUCTURAL FATIGUE TEST RESULTS FOR LARGE WIND TURBINE BLADE SECTIONS

J. R. Faddoul and T. L. Sullivan
NASA Lewis Research Center
Cleveland, Ohio

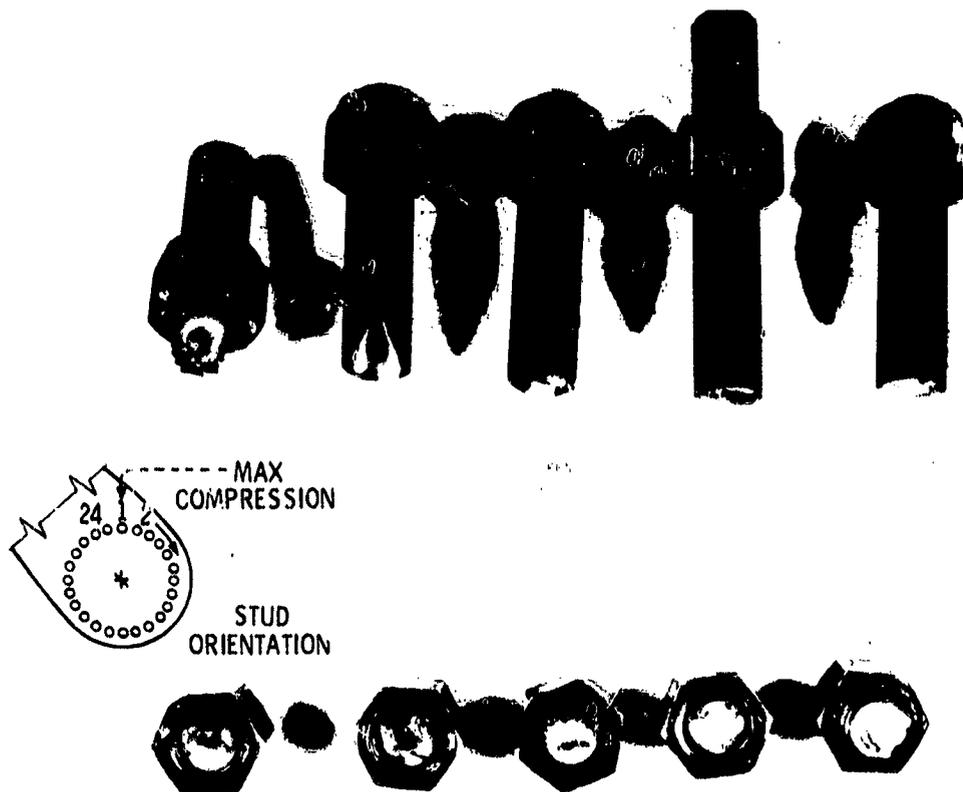
force in the studs resulting from the blade bending moment but by bending stresses in the bolts induced by bending of the backstop plate. Consequently, it was decided to reinforce the backstop plate by adding an extra H beam and to provide a very stiff, flanged, spool piece between the blade and the backstop. This spool piece, Figure 6, would be needed not only for testing, but for machine application. A spool piece was required for machine application because the Mod-OA flange was designed to mate with a similar flange on the original aluminum blades and was not stiff enough to support the wood blade directly.

Figure 5. - Broken bolts from first test of prototype wood blade section.

The blade section was returned to Gougeon Brothers, Inc., the manufacturer who replaced all 24 studs with the configuration shown in Figure 4b. The blade section and a boilerplate spool piece were then sent to Ft. Eustis to continue testing. One million cycles were run at maximum stud loads of approximately 10,000, 13,750, and 17,500 lbs (root moments of 84,000, 115,500, and 147,000 ft-lbs, respectively). No evidence of structural degradation could be found. At that point, the root moment was increased to 210,000 ft-lbs (maximum bolt load of 22,000 lbs) and an additional 670,000 cycles were accumulated. At that point, 7 studs were found to have failed. Failure was due to the sharp corner and consequent high stress riser at the transition from the 1" threaded shank to the 1-1/2" diameter collar (see Figure 4b). No evidence of any wood failure or significant epoxy fatigue could be found. Subsequent examination of the blade proved that the laminated wood construction had come through the test completely unaffected. A plot of the test points achieved and their relationship to operating loads and numbers of cycles is shown in Figure 7.

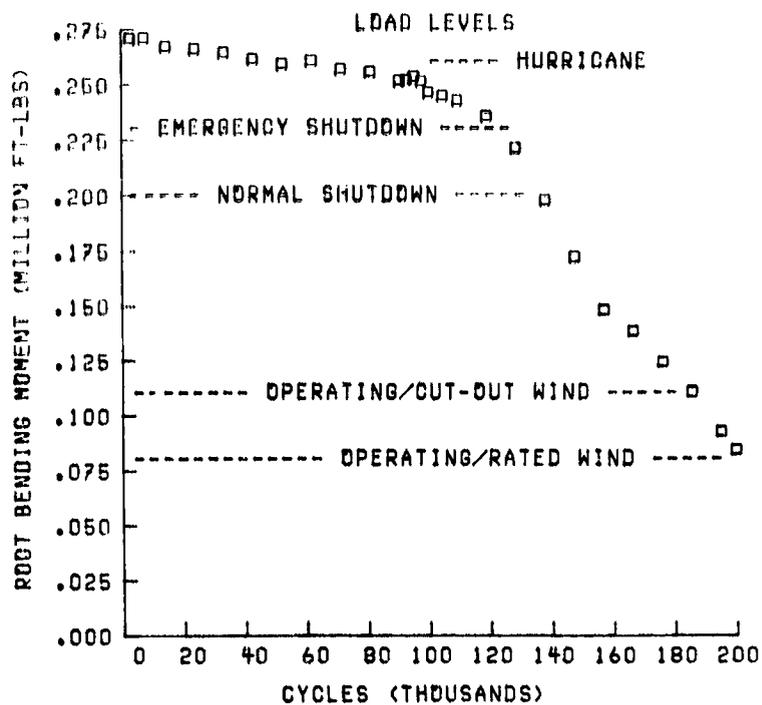
more than 100,000 cycles to root moments in excess of 225,000 ft-lbs before significant drop-off of load carrying capability was experienced. The LVDT data plotted in Figure 10 indicate that some deterioration of the root end was occurring even at a low number of cycles, since the gap opening was steadily increasing. Relatively speaking, the change in gap opening was minor, changing only .014 inches in 43,000 cycles, or .0003" per thousand cycles. When compared to the initial value, this is a change of 2% per 1000 cycles. However, at about 90,000 cycles, the rate of change took a sudden increase, which indicates that major structural damage had occurred. It took another 25,000 cycles before this damage was serious enough to cause significant loss in load carrying capability (see Figure 9).

Figure 9. - Stiffness degradation during fatigue test of laminated wood blade.

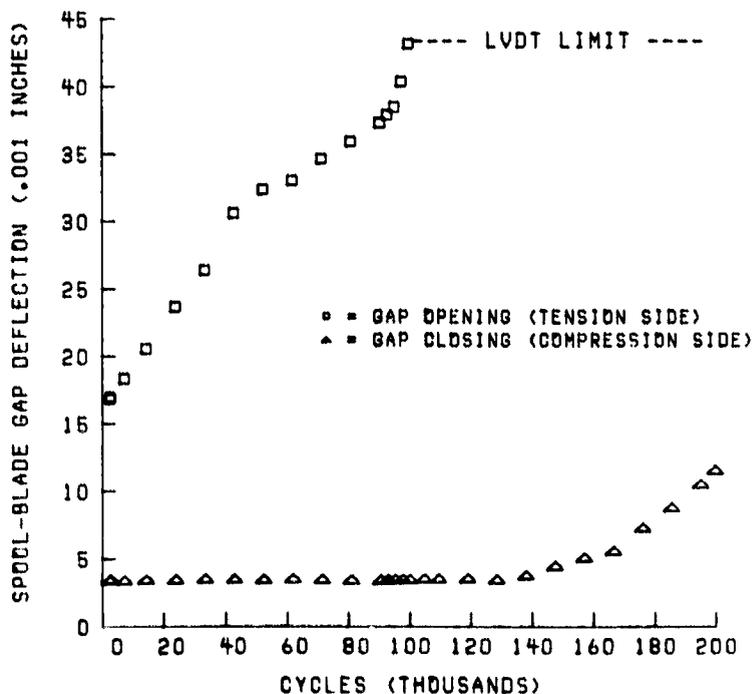
Figure 10. - Sensitivity of LVDT in measuring wood blade root end fatigue damage.

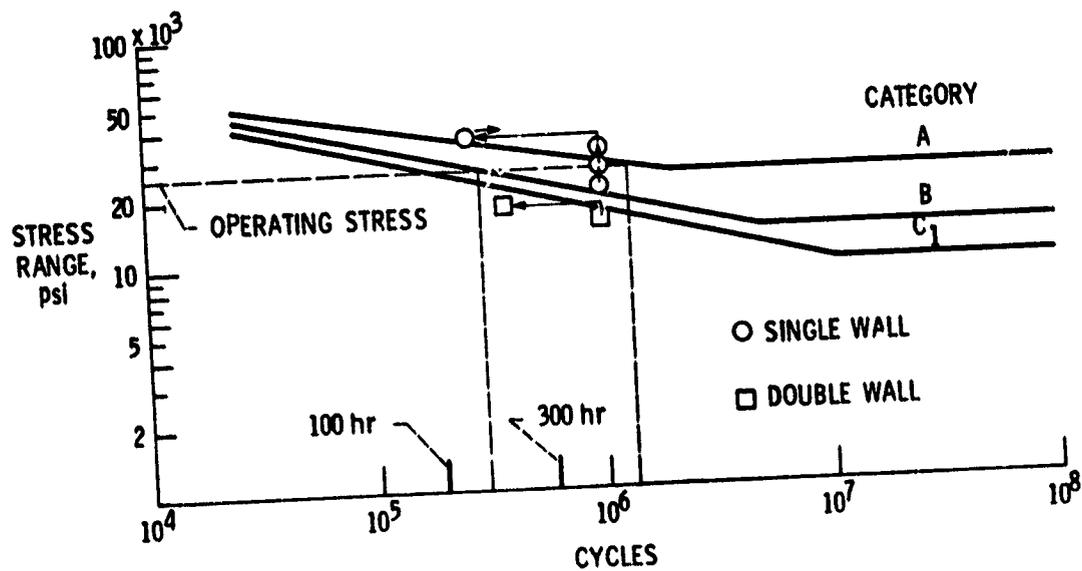
The spar was load cycled for 10^6 cycles at each step of increasing load until failure occurred. Failure occurred after 265,000 cycles at the fourth load level. This is shown graphically in Figure 14. The stress level indicated on the graph was calculated using simple beam theory. Failure occurred in the flange radius. Failure here rather than in the weld is attributed to the low strength of the plate material from which the flange was machined and the orientation of the grain structure with respect to the applied stress. Figure 15 compares the grain structure of the plate material with that of a forged material. The plate material was stressed transverse to the grain direction. Fatigue strength transverse to the grain direction has been shown to be significantly less than that parallel to the grain direction (Ref. 4). The forging process eliminates elongated grain structure and reduces fatigue strength sensitivity to stress direction. Subsequent flanges for spar blades have been machined from forgings.

Because failure occurred outside the weld area, the fatigue strength of the weld was not determined. However, certain conclusions can be drawn by comparing the test results to the fatigue stress levels allowed by the Structural Welding Code for tubular structures

(Ref. 5). In Figure 14 the single wall test results can be compared to three weld categories: Category A is plain, unwelded pipe; Category B is for butt splices with full joint penetration where the weld is ground flush and inspected by radiograph or ultrasound; and Category C is the same as B without the grinding and inspection requirements. The original inspection interval of 100 hours was set using Category B allowables. As the figure shows, the test data exceed Category A allowables. Therefore, a new inspection interval of 300 hours was set based on Category A allowables. It should be noted that in earlier versions of the Structural Welding Code, a high quality welded joint could be placed in Category A.

Figure 14. - Comparison of steel spar test results to Structural Welding Code allowables.

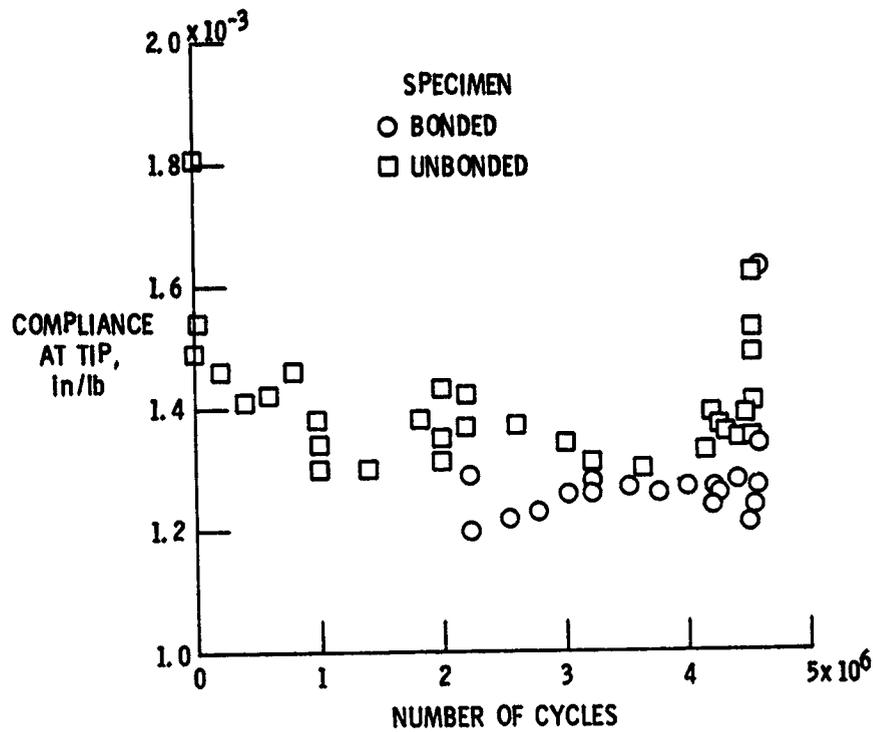
During initial load cycling of the unbonded specimen motion was detected between the composite and steel retention. As the test progressed, this motion decreased even though the load was periodically increased. This behavior is shown graphically in Figure 21 where the compliance at the tip of the beam (deflection per unit of applied load) is plotted against number of cycles. The plot shows the compliance steadily decreasing for the first half million cycles. This behavior was probably caused by the composite being wedged on the tapered portions of the steel retention ring. If it had been possible to run the test with reversed bending, it is likely that high tip compliance and motion between composite and steel would have been observed during the entire test.

Compliance data for the bonded specimen after it had been cycled 2.22×10^6 times and rotated 90° is also shown in Figure 21. On average, the compliance of the bonded specimen is about 10 percent less than that of the unbonded one. Also, the data scatter for the bonded specimen is less. This kind of behavior would be expected. After about 4.5×10^6 cycles both specimens showed a very rapid increase in compliance. This is related to the failure in the flange fillet.

Figure 21. - Effect of load cycling on compliance of fiberglass fatigue specimens.

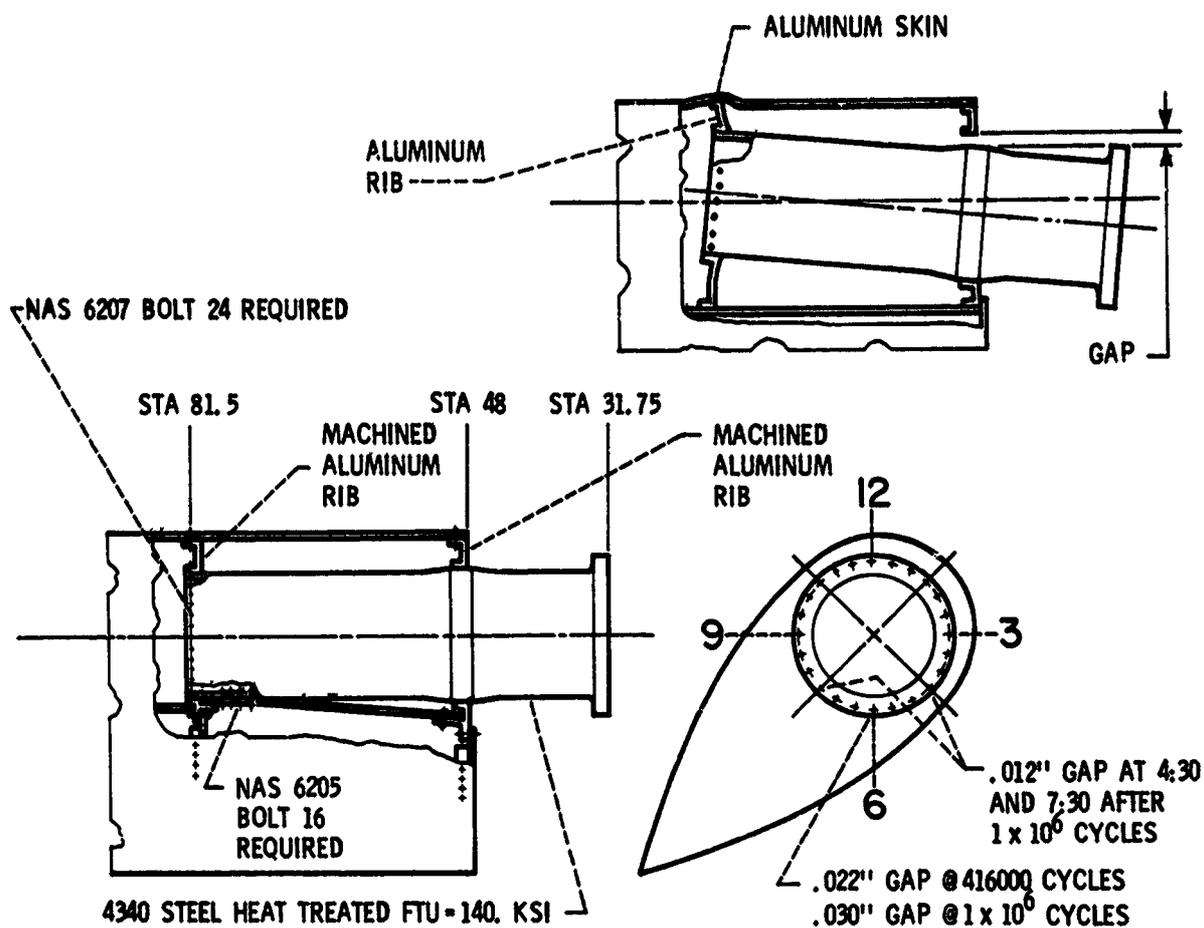
Testing was started with a shear load of 5900 pounds required to produce the Station 81.5 moment of 103,400 foot/pounds. This load level should have produced no problems in the aluminum blade based on design capabilities. However, as soon as testing started, it was evident that the root end load transfer from the innermost rib (Station 48) to the gunbarrel section (Figure 23), was inadequate. Considerable scraping and wear began immediately. This was directly comparable to what had already been experienced in the field and had resulted in the incorporation of a shim (or bearing surface) with high hardness and low coefficient of friction between the steel root end fitting and the aluminum rib at Station 48. Testing was allowed to continue at the 5900 pound shear level with the intention of shimming the Station 48 rib as soon as wear became excessive. A cyclic rate of 2 Hz was maintained; at about 500,000 cycles a loud popping noise was heard. A similar noise was heard again at about 900,000 cycles. One million cycles were completed without obvious external cracks, although it is probable that internal damage had occurred. Wear, as shown in Figure 23, had not progressed to the point where shims were required.

Figure 23. - Mod-0 aluminum blade root end details and wear pattern.

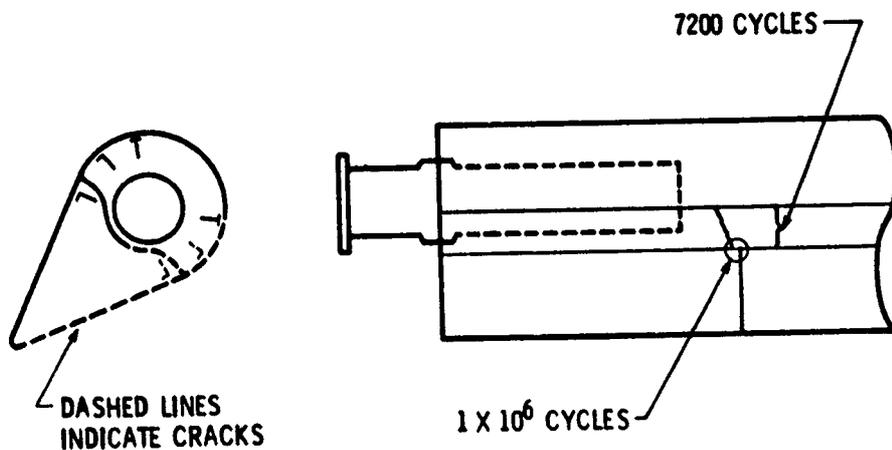
The shear load was increased to 7900 pounds, which represented the 40 MPH, 40 RPM case, and several more loud popping noises were heard immediately. After only a few hundred cycles, a skin crack was noticed in the trailing edge, extending 6 inches into the D spar skin. The extent of the crack is shown in Figure 24. The test was allowed to continue for another 55 minutes or until a total of 8778 cycles had been accomplished at 7900 pounds. At that point, the crack had grown further into the D spar skin and testing was terminated. The blade was removed from the test stand and returned to LeRC for inspection, which resulted in the following observations (refer to Figure 24):

1. The crack extended from the trailing edge through an internal splice plate at Station 88 all the way forward and 14 1/2 inches into the intermediate (D spar) skin.
2. The aft stringer was broken.
3. The middle stringer was broken.
4. The crack also extended up into the shear web for about half the blade thickness (10 inches).
5. The crack terminated in a rivet hole in the forward stringer.
6. The forward stringer was not broken.

This type of failure was typical of a particular mode of failure that was experienced on the Mod-OA machines. Dusting of rivets in the trailing edge skins was also typical of blades in the field. The test section, however, did not exhibit rivet dusting since the test blade section had a trailing edge skin that was much thinner than the

Figure 24. - Damage resulting from fatigue test of Mod-0 aluminum blade.
